## 438. Moser Tower cracking

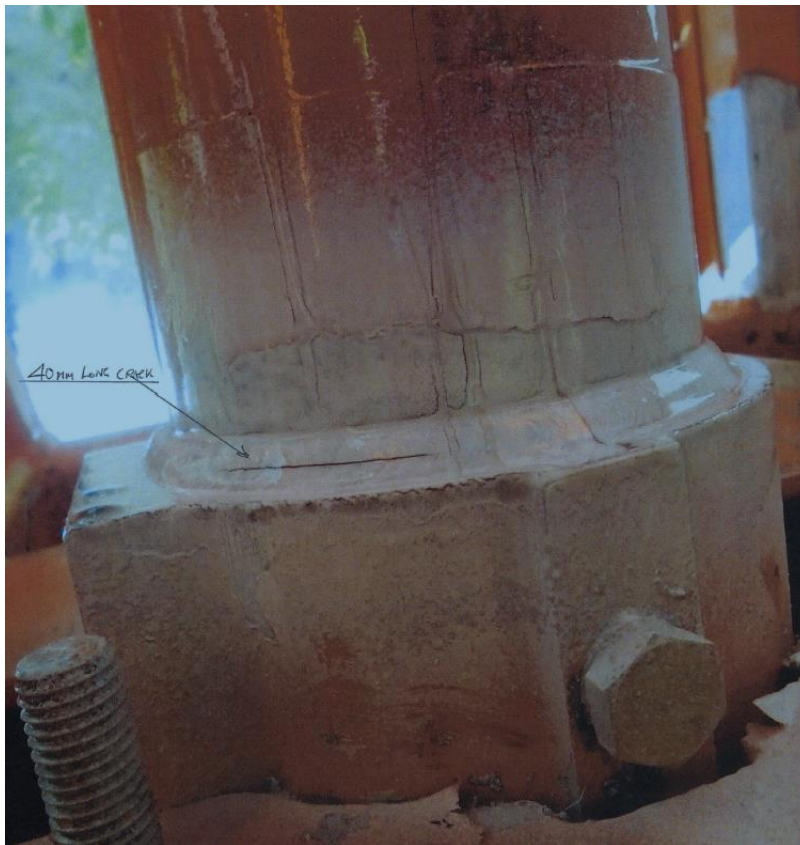
NAFLIC would like to make inspection bodies and controllers aware that cracking has been detected on at least three Moser tower rides (of various ages) during routine annual inspections. The cracks, 25 - 40 mm in length, were present on the upper and lower fillet welds for the collar housing the upper feed gland. Please refer to the photographs below.

40mm long crack

Inspection bodies and controllers should pay close attention to these areas during annual inspections and routine ride checks. Note – oil loss will be visible at source and apparent in the system if such a defect occurs.
