438. Moser Tower cracking

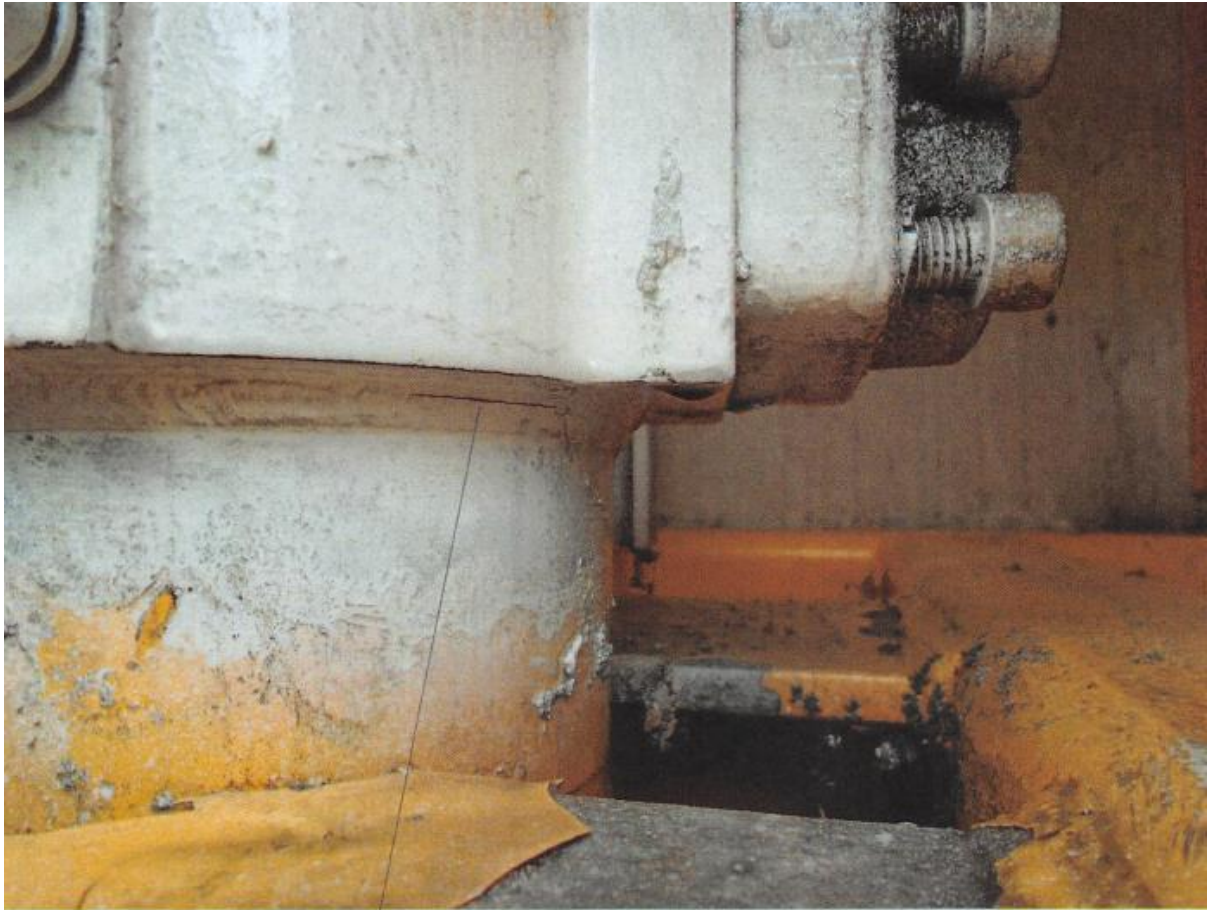
NAFLIC would like to make inspection bodies and controllers aware that cracking has been detected on at least three Moser tower rides (of various ages) during routine annual inspections. The cracks, 25 - 40 mm in length, were present on the upper and lower fillet welds for the collar housing the upper feed gland. Please refer to the photographs below.

25mm long crack revealed by MPI

Inspection bodies and controllers should pay close attention to these areas during annual inspections and routine ride checks. Note – oil loss will be visible at source and apparent in the system if such a defect occurs.
