485.

Moser's Rides tower ride/spring ride

This bulletin concerns the threaded connection between the ram and the pulley frame on Moser's Rides' spring and tower rides.

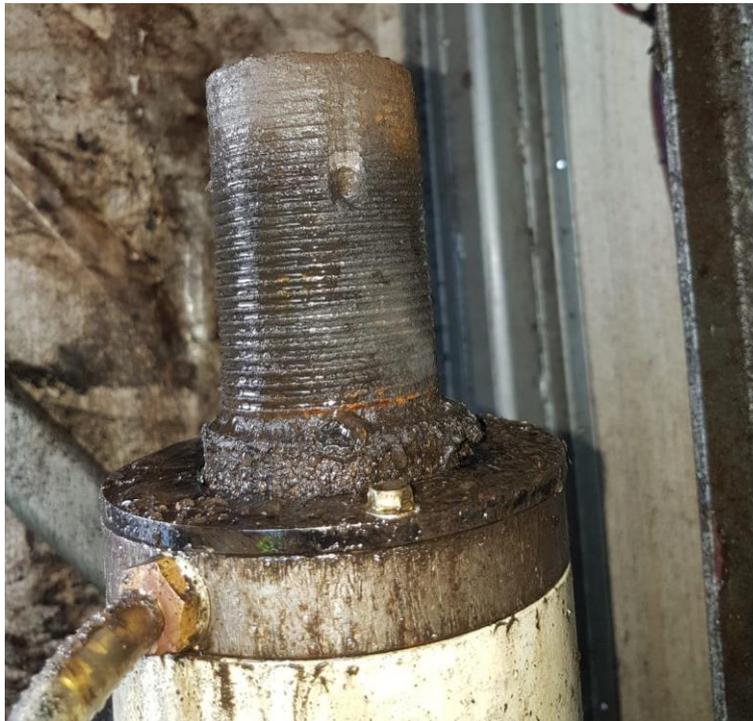
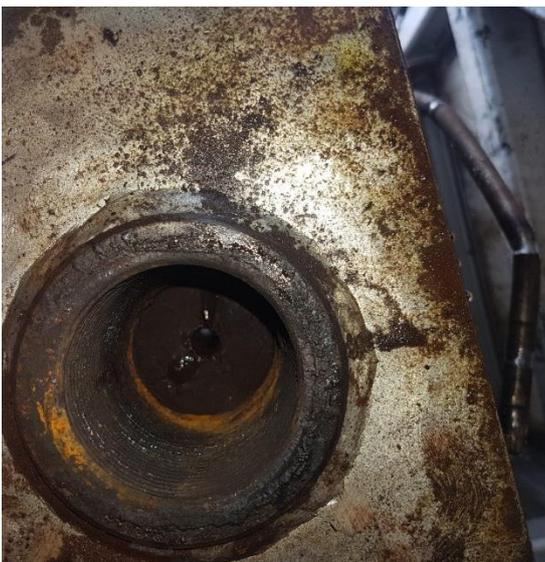
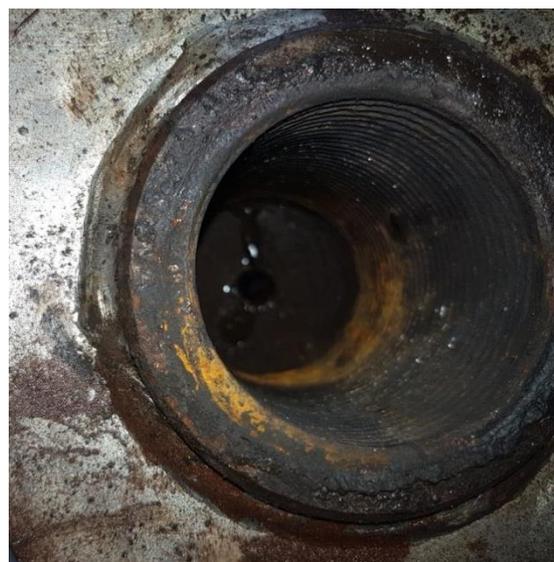
During an annual inspection a UK registered inspection body identified damage to the threads on the ram rod of the double acting cylinder. The condition of the ram, and the pulley frame to which it connects, can be seen in the photographs below.

The connection is a single point failure, the unfastening or failure of which could result in the passenger-carrying bench falling onto the dampers (possibly from a considerable height).

It should also be noted that whilst we are passing both bulletins on for information this is not to say that the Standards Committee endorses either of them. We do, however, wish to ensure that all relevant parties are aware of the problem and we urge all controllers and inspection bodies to ensure that due attention is paid to these areas during daily, weekly and monthly checks as well as during annual inspections.

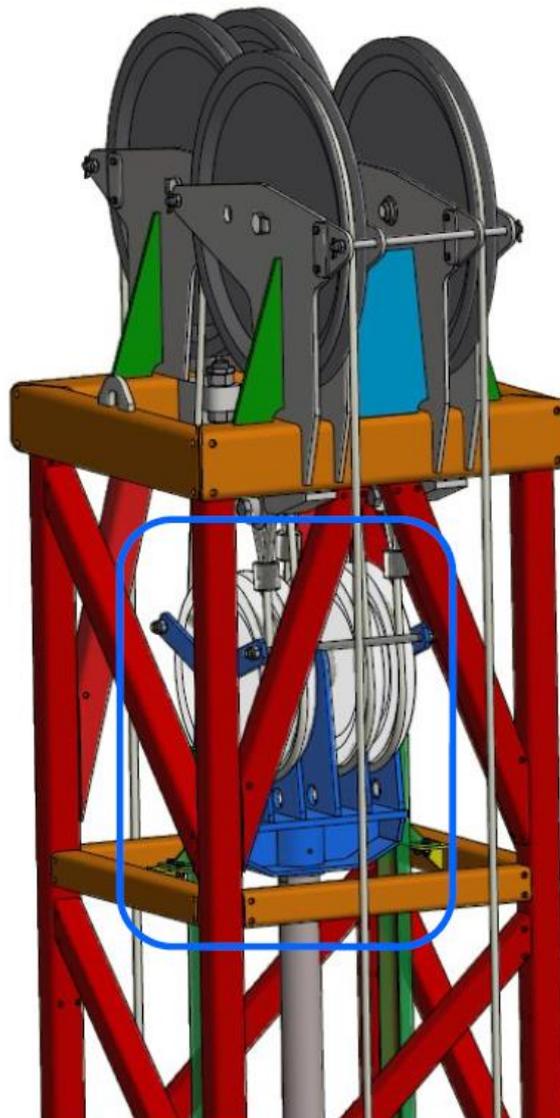
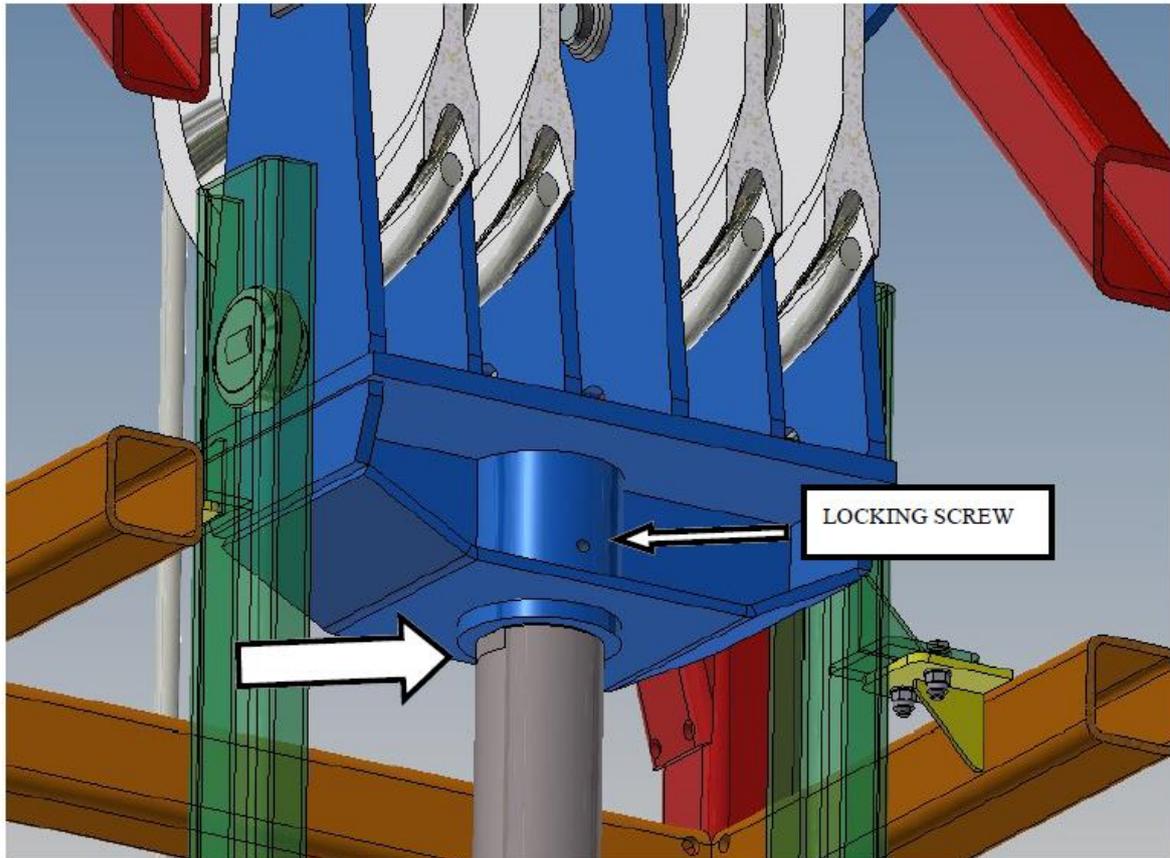
Cylinder Shaft- Pulleys Support Tightening Control

VISUALLY CHECK EVERY 2 WEEKS THE TIGHTENING OF THE CYLINDER SHAFT AND PULLEY BLOCK. THEY MUST BE PROPERLY CONNECTED. MARKING A VISUAL REFERENCE AMONG THE 2 PARTS MIGHT HELP TO DETECT ANY UNSCREWING.

**THE PULLEY BLOCK MUST BE COMPLETELY PLUGGED INTO THE CYLINDER SHAFT.
IF NOT IT MUST BE TIGHTEN BACK INTO POSITION:**

- A) REMOVE THE LOCKING SCREW.
- B) BY A LARGE WRENCH KEY LOCK THE SHAFT BY THE 2 FLAT TABS AND TIGHT IT ANTICLOCKWISE ALL THE WAY TO THE LIMIT
- C) RESTORE THE LOCKING SCREW

VISUALLY CHECK EVERY 2 YEARS (APPLICABLE ONLY FOR UNITS THAT HAVE BEEN OPERATING FOR 5 YEARS UNLESS THE FACTORY ACCUMULATOR SETTINGS HAVE BEEN ALTERED: 50 BAR AND THE REVERSE THRUST OF 2,5 G) THE CYLINDER SHAFT AND PULLEY BLOCK THREADS BY CHECKING THE INTEGRITY OF THE THREADS.

IF BY VISUAL CONTROL ONE OR BOTH OF THE TWO THREADS IS WORN OR DAMAGED, THE CYLINDER SHAFT AND THE PULLEY BLOCK SHALL BE REPLACED WITH NEW UNITS.

THE INDIVIDUAL DAMAGE OF ONLY ONE OF THE TWO ITEMS REQUIRES A FULL REPLACEMENT OF BOTH THE SHAFT AND PULLEY PACK.

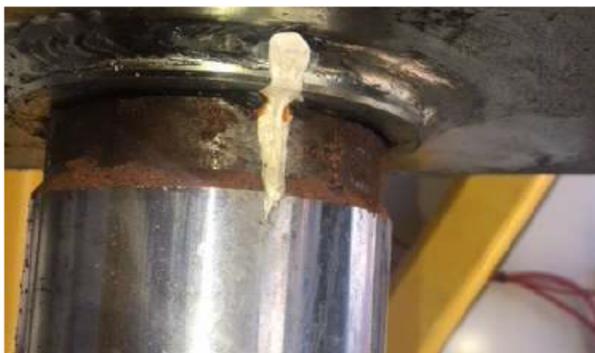
EXAMPLE OF A MARKED REFERENCE

Paint a vertical stripes between the cylinder and the pulley pack as shown in the following picture:

- Weekly Visual Inspection.
The visual inspection defined in this bulletin can be performed by a competent owner/operator.

At the first sign of baking off or dropping the Cylinder and Pulley connection, the Cylinder and Pulley Block shall be replaced with new units.
