## Lifting Paratrooper weld failure

A UK inspection body has recently been informed of a car attachment pin weld failure on a Lifting Paratrooper made by Hrubetz in 1979. Fortunately the failure occurred during the dismantling of the ride. However, the exact events that lead to the component failure are still not known.

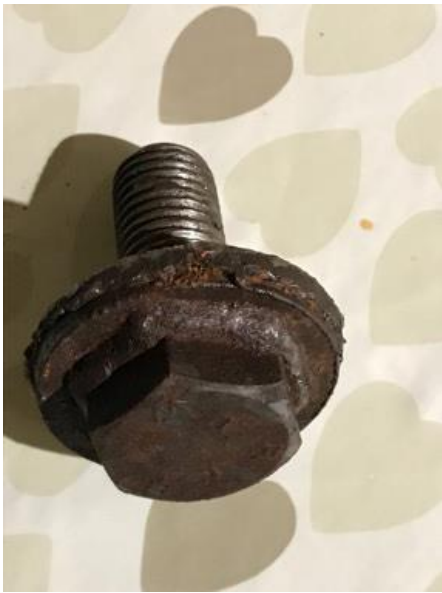
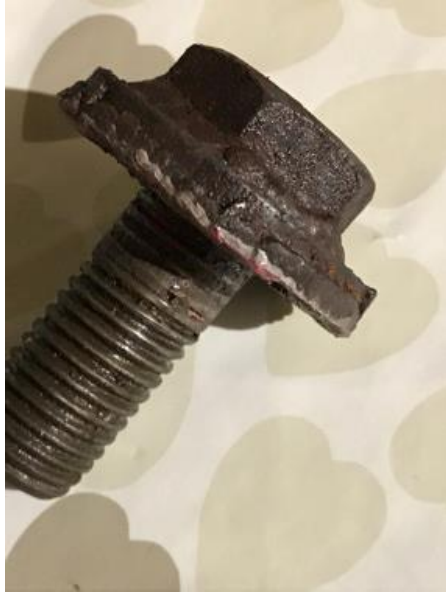
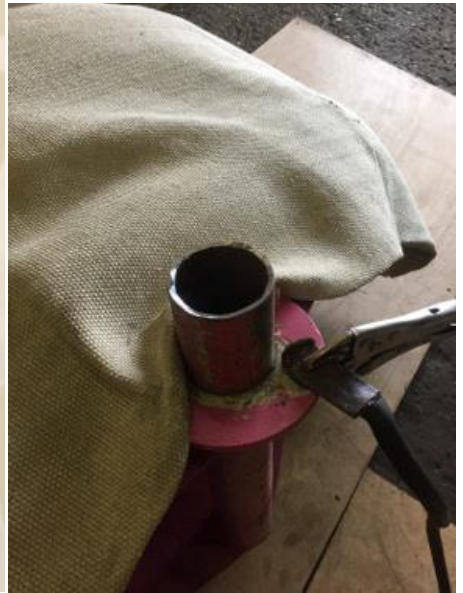
Figure 1

It appears that the weld around the plate that holds the attachment bolt to the car frame failed and allowed the bolt to come away from the car frame. (See figure 1)

The failure could be due to a variety of factors such as:

- Poor manufacturing welds
- Over stressing of the weld due to over tightening of the securing bolt
- Weld fatigue due to age
- Severe impact during take down procedure

The IB involved is recommending its clients take the following action before their ride is next operated:

- Remove all cars and visually check the area for indications
- If operators are unsure they should have this done by an ADIPS registered NDT inspection body
- If it is not already, this weld should be added to the ride NDT schedule and checked annually with MPI. The defect criteria would be no cracks
- Should any defects be found all car attachment bolts should be replaced immediately

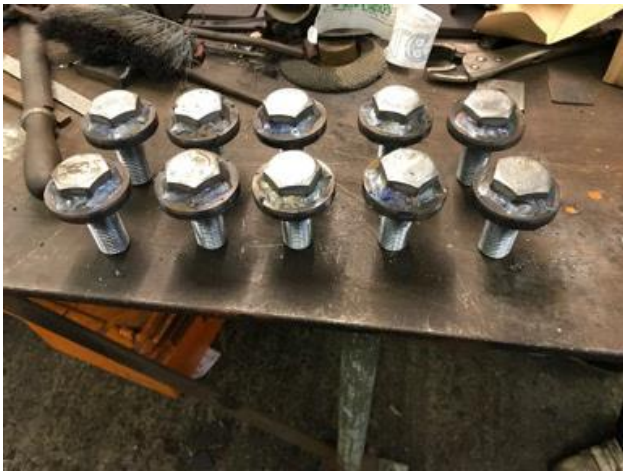
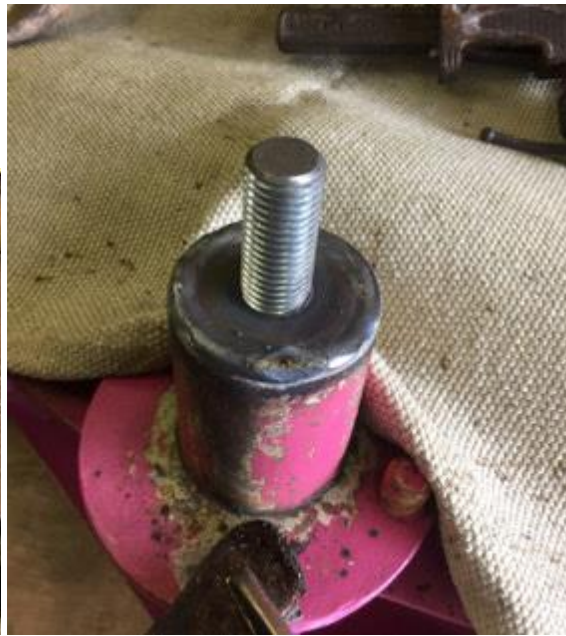
Figure 2

In this case the operator has opted to replace all 10 car attachment bolts. (See figure 2)

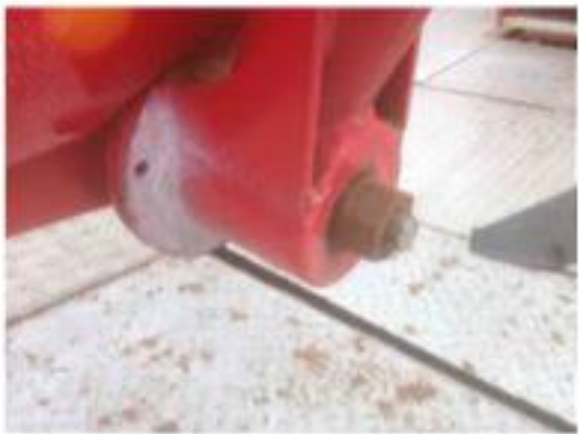
General image of component when assembled
